Procyon Errata Sheet

12/27/06

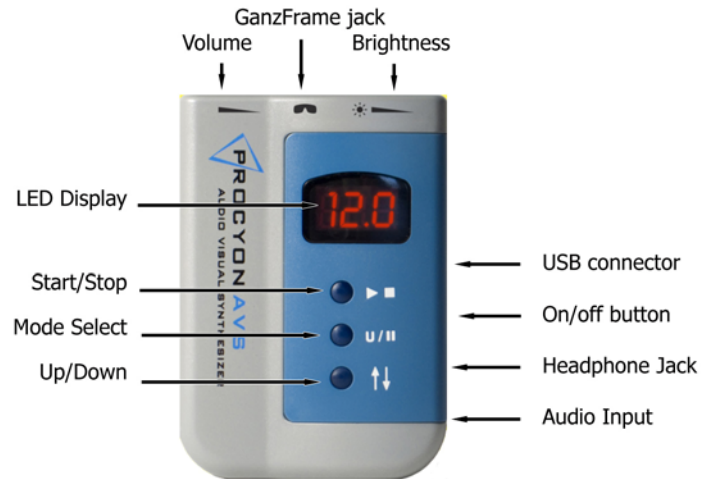
1. **Connector location.** The USB and start/stop button positions were reversed. The proper diagram follows:
